United States Department of the Interior National Park Service
NATIONAL REGISTER OF HISTORIC PLACES REGISTRATION FORM

Historic name: Mount Saint Joseph

Other name/site number: Holloway Estate

Street & number: 137 Mt. Saint Joseph Road not for publication: N/A
City/town: Wheeling vicinity: X
State: West Virginia code: WV county: Ohio code: 069 zip code: 26003

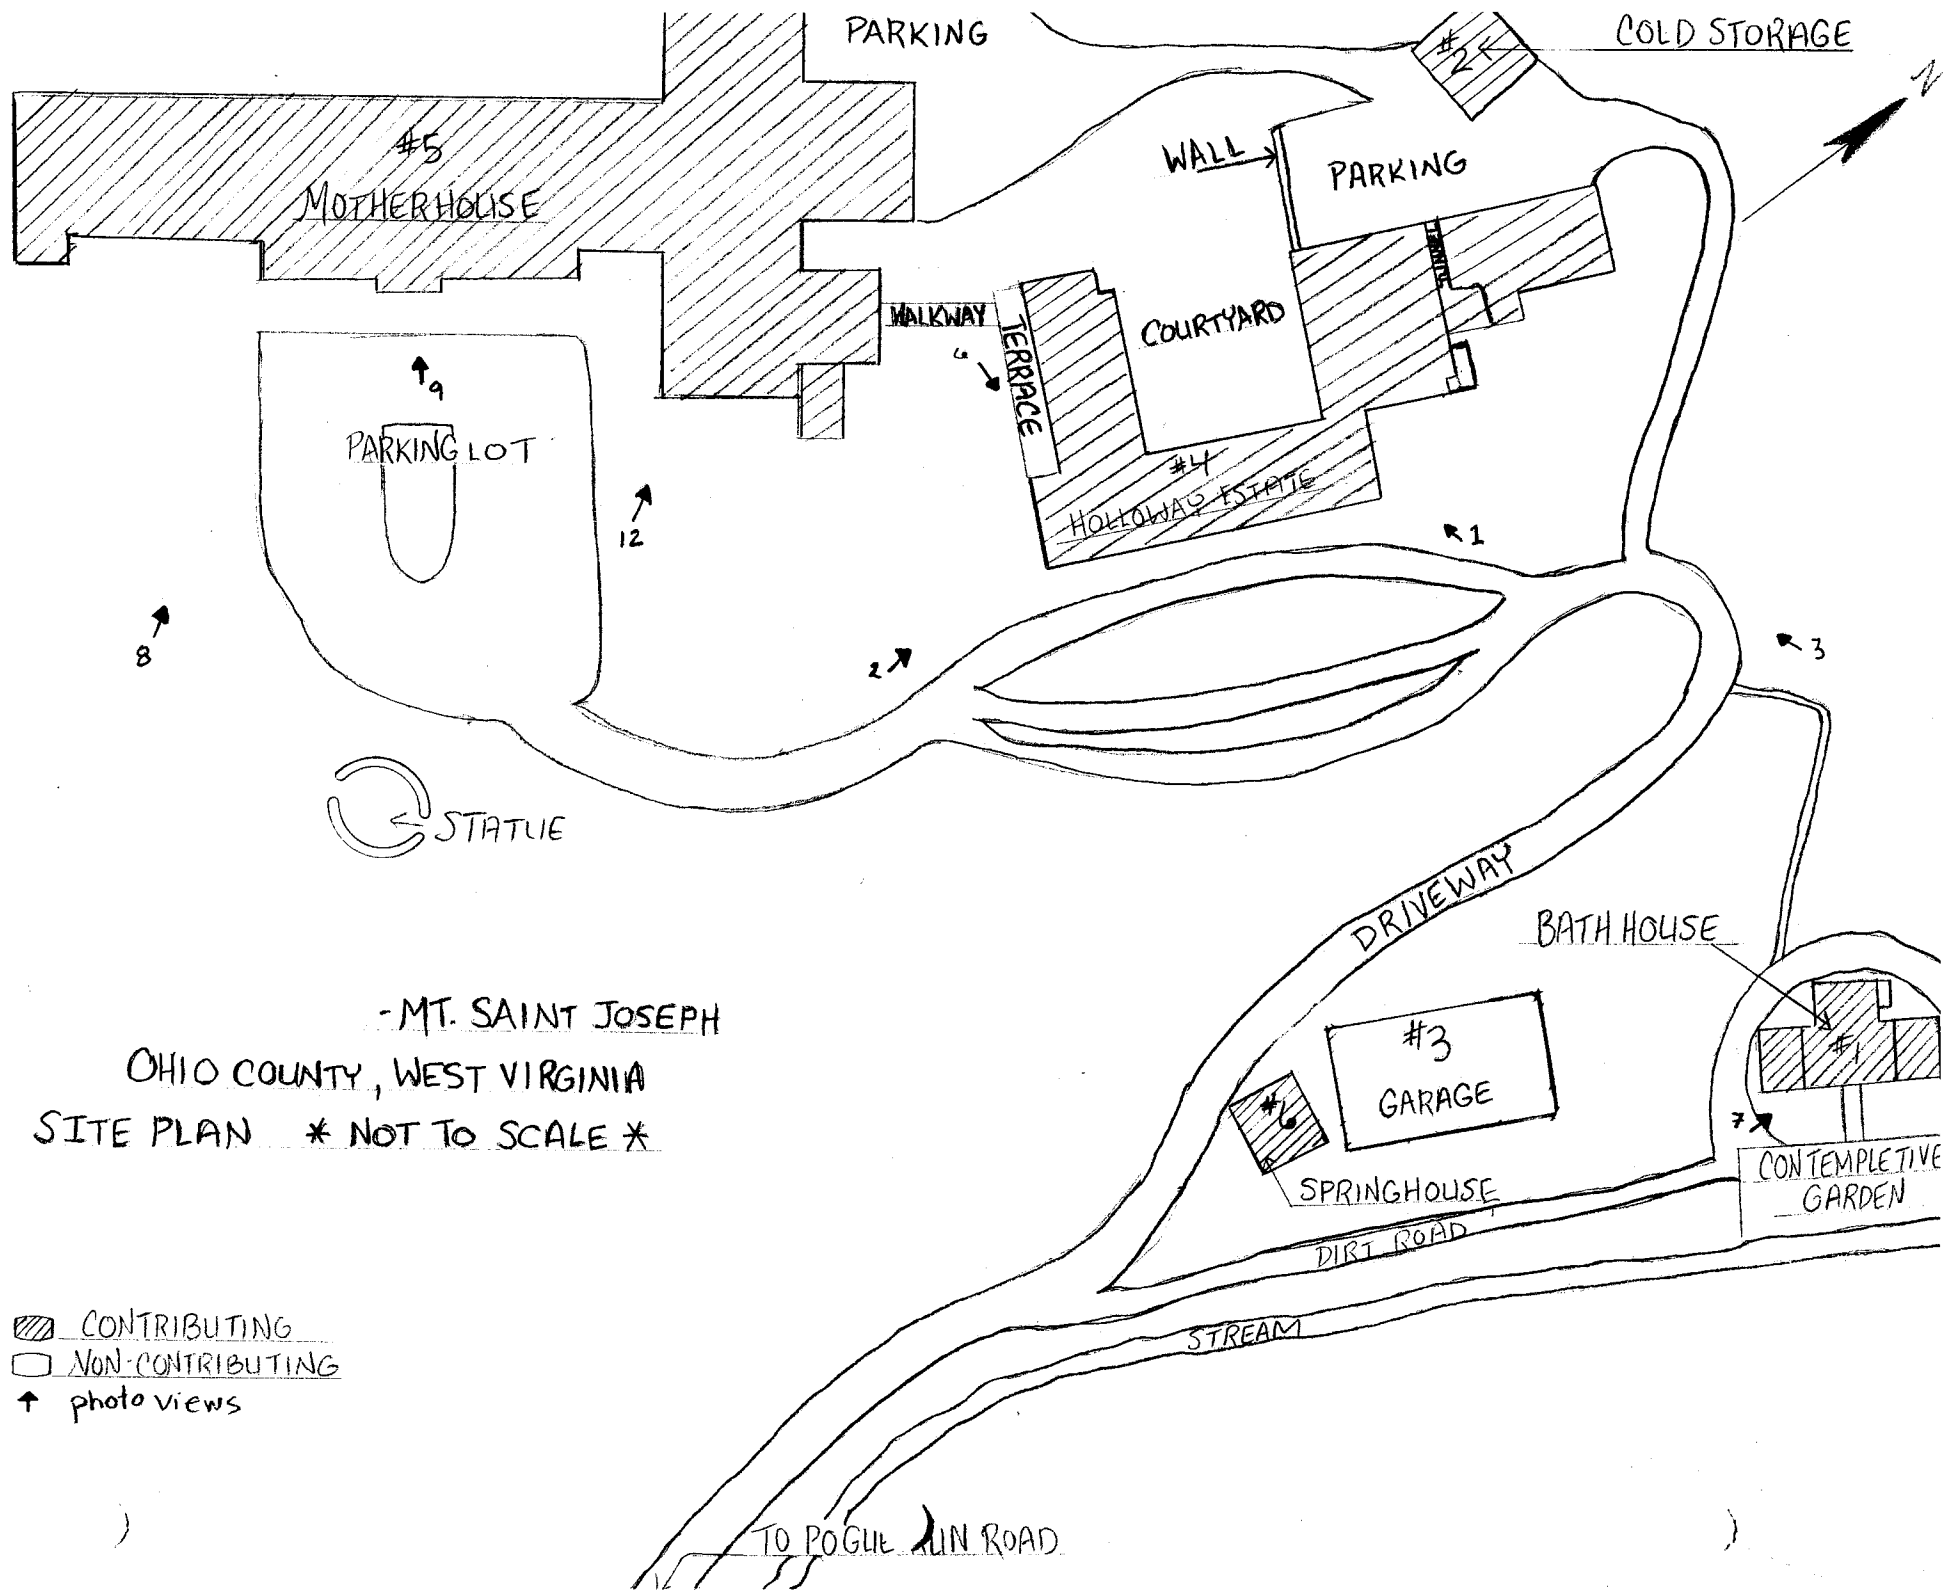
- MT. SAINT JOSEPH
 OHIO COUNTY, WEST VIRGINIA
 SITE PLAN * NOT TO SCALE *

- CONTRIBUTING
- NON-CONTRIBUTING
- photo views

Bathhouse- Contributing [#1 on site plan]

Cold-Storage Building-Contributing [#2 on site plan]

Garage-Noncontributing [#3 on site plan]

Holloway Residence-Contributing [#4 on site plan]

Motherhouse-Contributing [#5 on site plan]

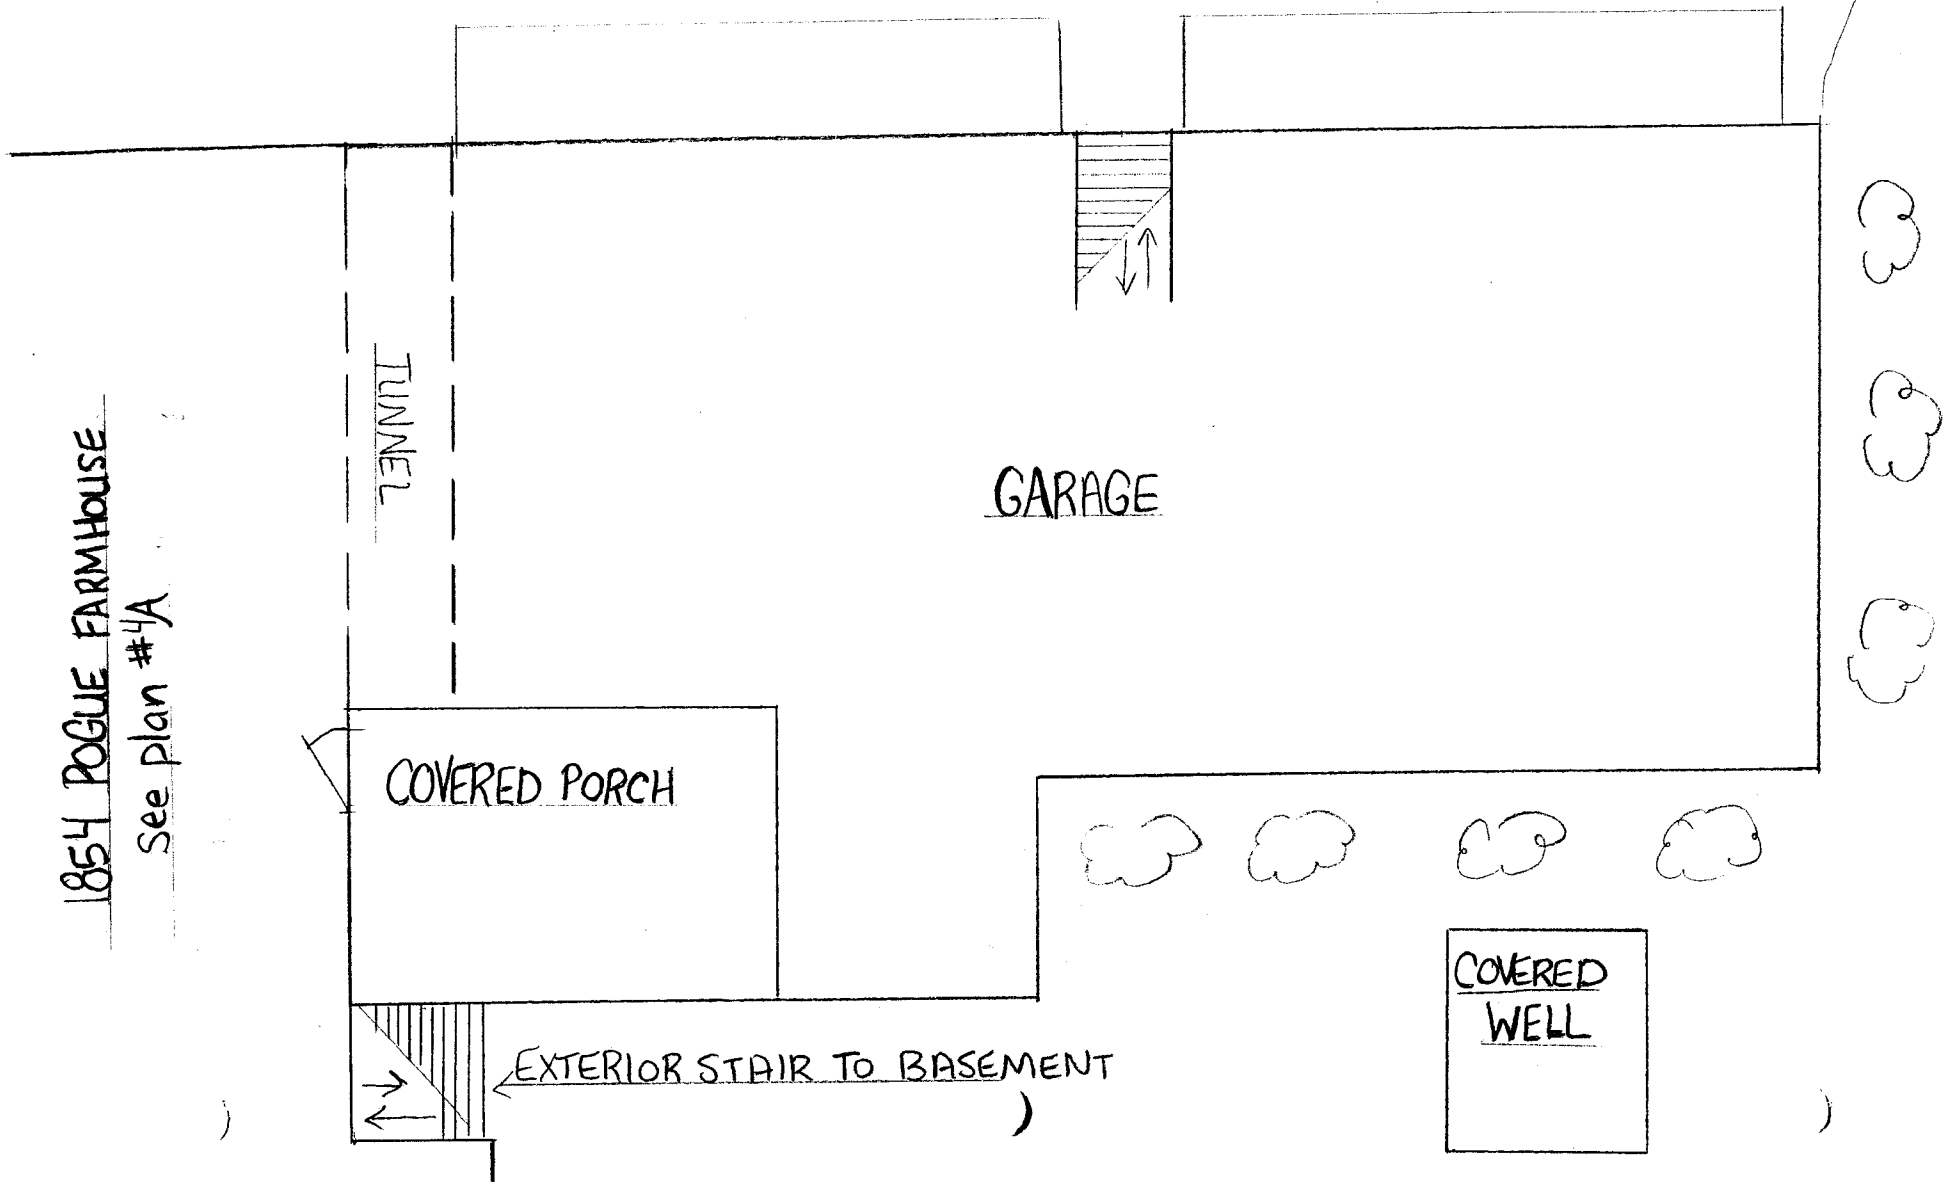
2nd FLOOR, PLAN B
OHIO COUNTY, WEST VIRGINIA
NOT TO SCALE

1854 POGUE FARMHOUSE
See plan #4A
